Flood Control Project Maintenance
2008 Structure Summary Report
Overall Unit and Item Ratings

Lower San Joaquin Levee District

2008 Structure Inspection Results

Inspection Report - Structure 2008

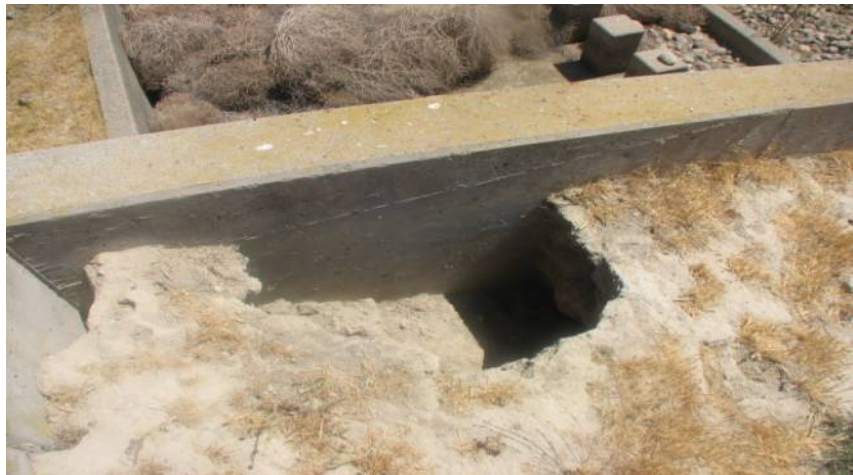
Report Line	4
Location	
Category	Structures & Concrete Lined Channels
Item	Erosion Areas

Looking at minor erosion on the left wing wall

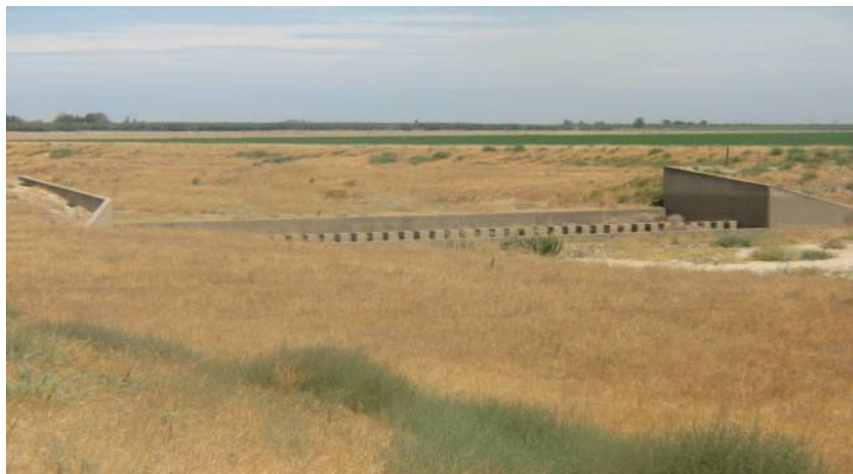
Report Line	6
Location	
Category	Structures & Concrete Lined Channels
Item	Concrete Foundations

Looking at the downstream side of the structure

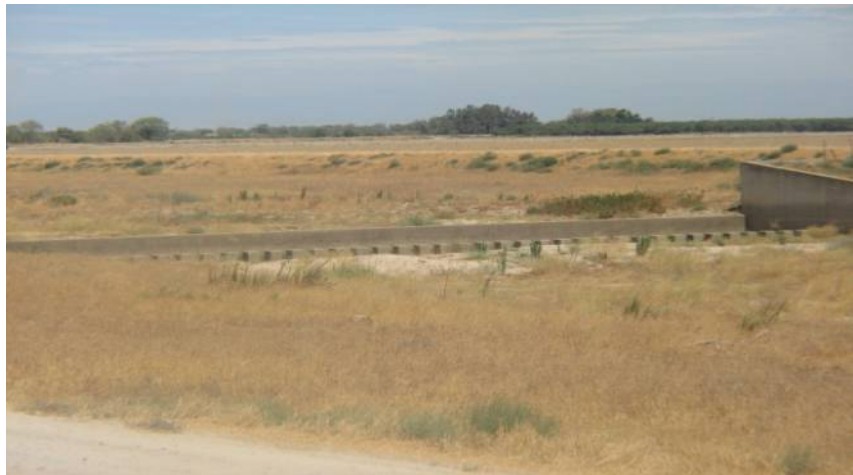
Report Line	6
Location	
Category	Structures & Concrete Lined Channels
Item	Concrete Foundations

Looking at downstream side of the structure.

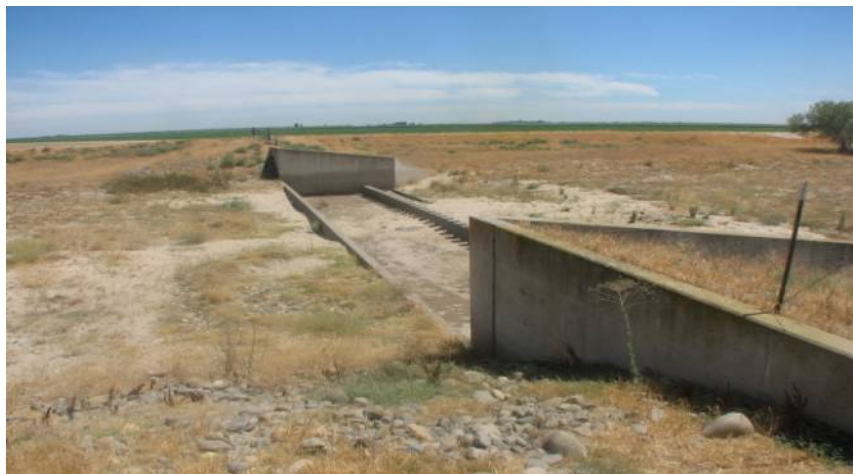
Report Line	6
Location	
Category	Structures & Concrete Lined Channels
Item	Concrete Foundations

Looking at dwnstream side of the structure.

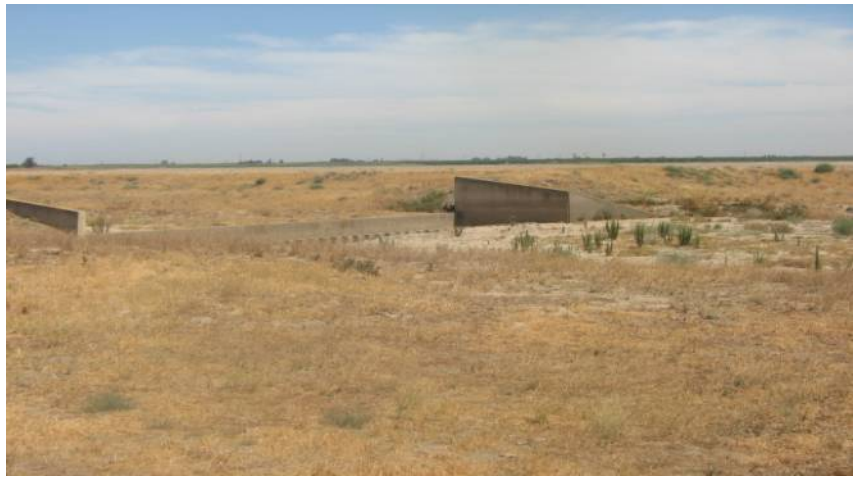
Report Line	5
Location	
Category	Structures & Concrete Lined Channels
Item	Concrete Foundations

Looking at downstream side of the structure.

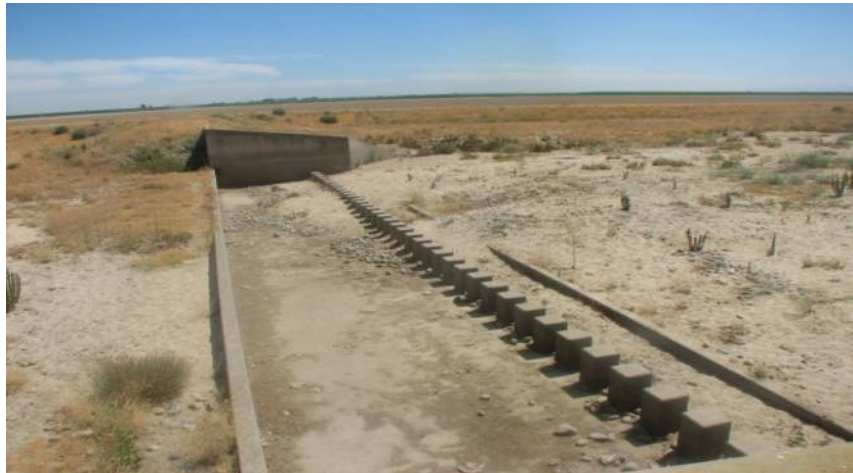
Report Line	5
Location	
Category	Structures & Concrete Lined Channels
Item	Concrete Foundations

Looking at upstream side of the structure

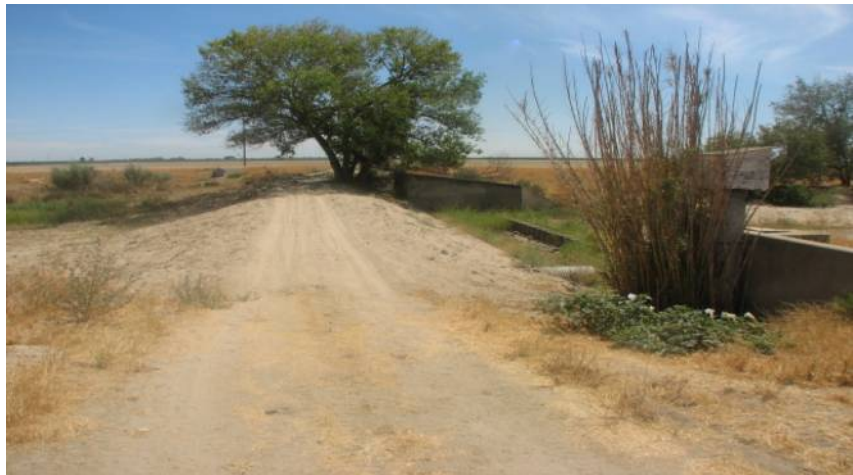
Report Line	2
Location	
Category	Structures & Concrete Lined Channels
Item	Encroachments

Looking at seasonal sand dam on the upstream side of the structure

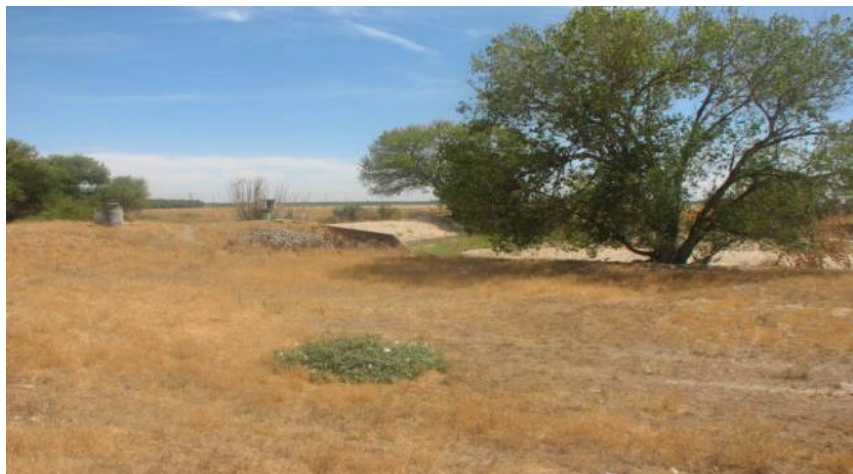
Report Line	5
Location	
Category	Structures & Concrete Lined Channels
Item	Concrete Foundations

Looking at the downstream side of the structure

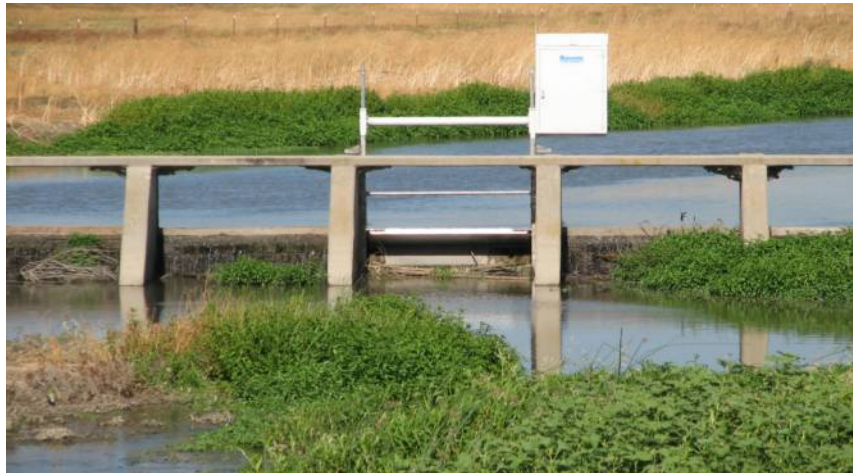
Report Line	4
Location	
Category	Structures & Concrete Lined Channels
Item	Electric Gate Operators

A Automatic Tide Flow Gate on upstream side of the structure

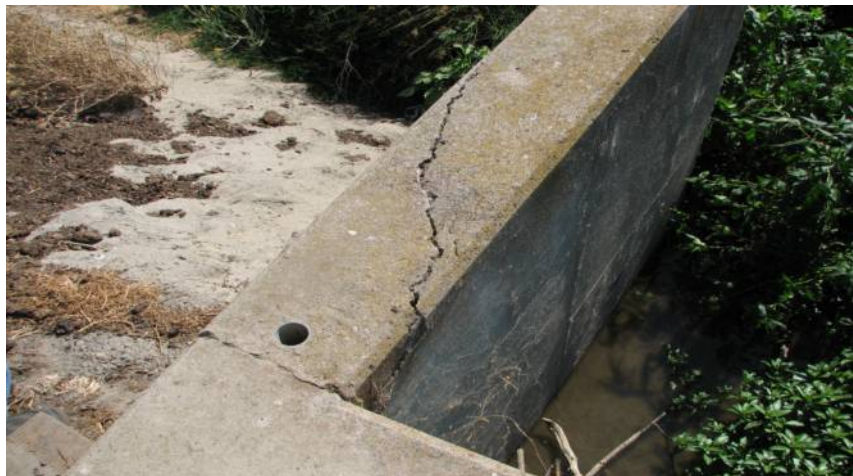
Report Line	5
Location	
Category	Structures & Concrete Lined Channels
Item	Concrete Surfaces

Crack on the downstream north wing wall.

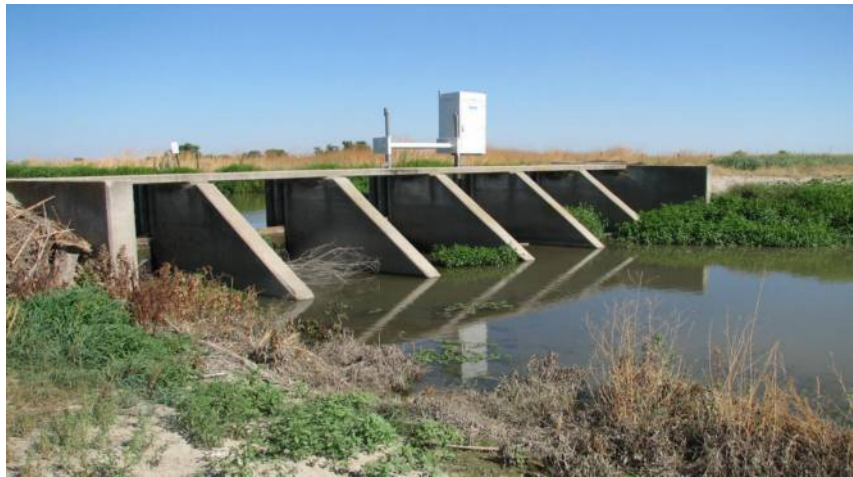
Report Line	6
Location	
Category	Structures & Concrete Lined Channels
Item	Concrete Foundations

Looking at the downstream side of the structure.

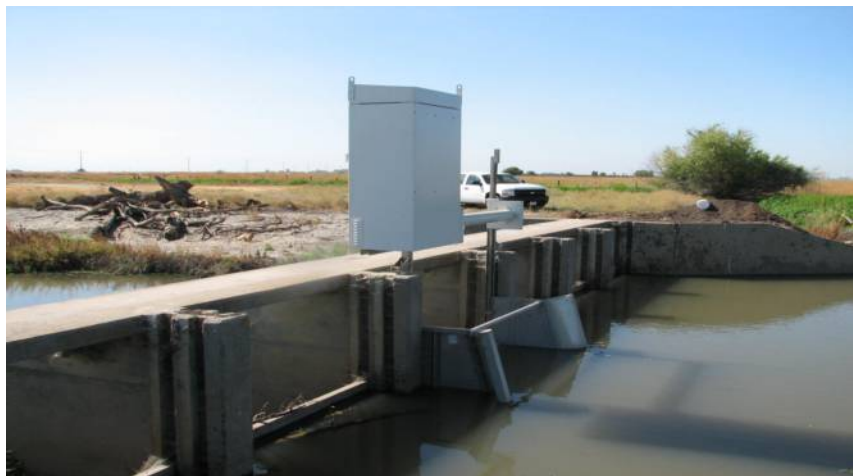
Report Line	6
Location	
Category	Structures & Concrete Lined Channels
Item	Concrete Foundations

Looking at the automatic tide flow gate on the upstream side of the structure

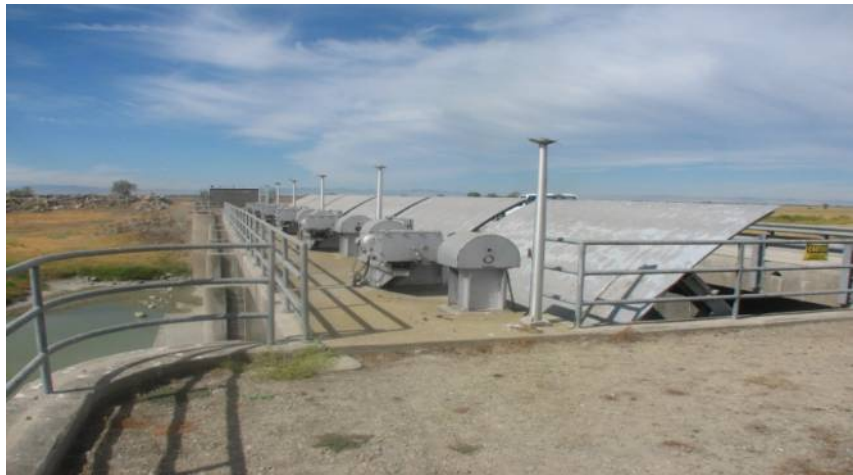
Report Line	2
Location	
Category	Pump Stations
Item	Motors, Engines, Fans & Gear Reducers

Looking at motors and gates on the upstream side of the structure

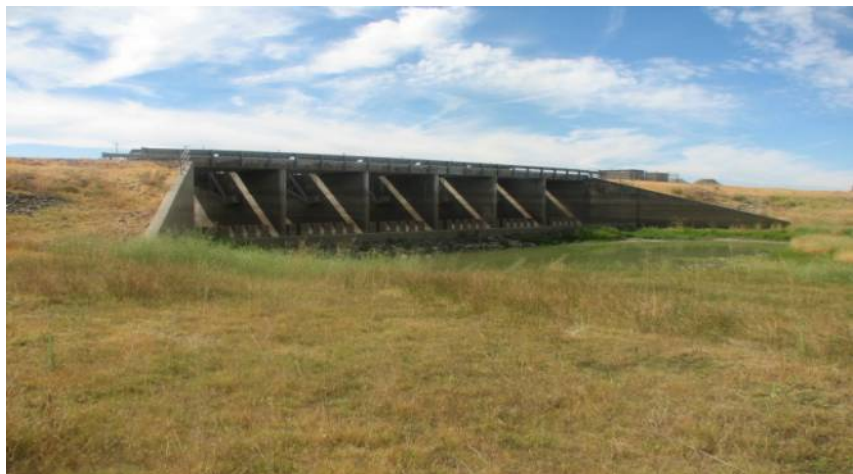
Report Line	8
Location	
Category	Structures & Concrete Lined Channels
Item	Concrete Foundations

Looking at the downstream side of the structure.

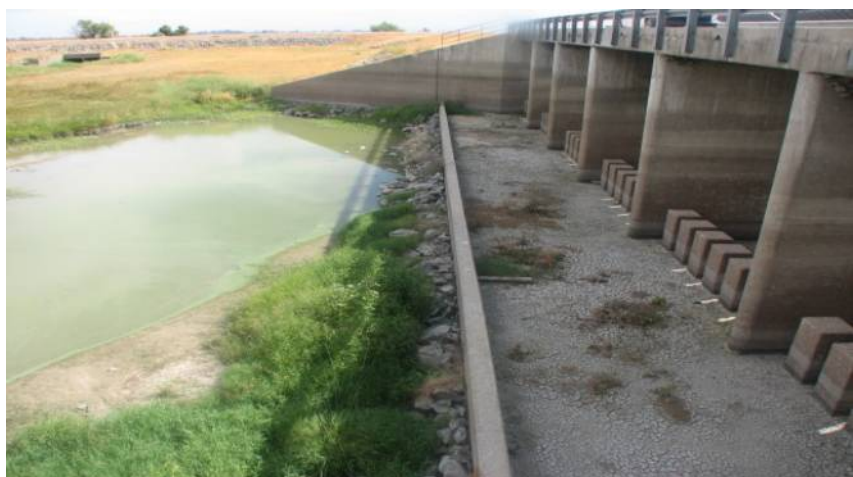
Report Line	8
Location	
Category	Structures & Concrete Lined Channels
Item	Concrete Foundations

Looking at upstream side of the structure

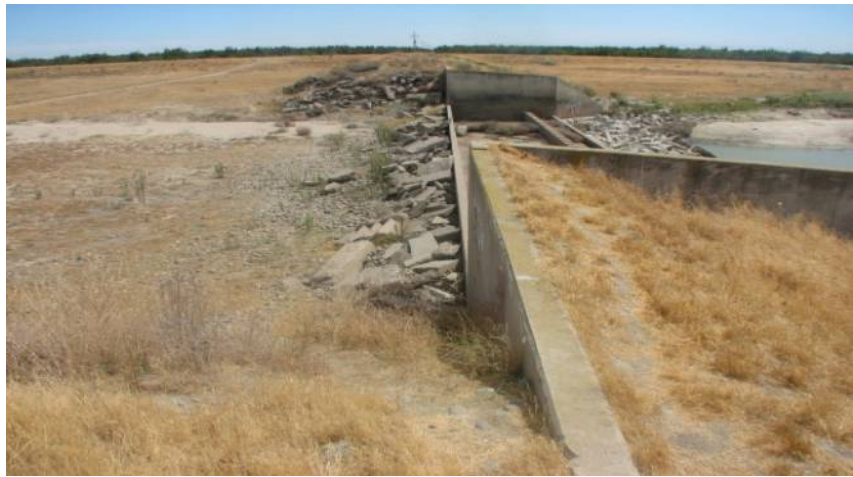
Report Line	5
Location	
Category	Structures & Concrete Lined Channels
Item	Concrete Foundations

Looking at the upstream side of the structure

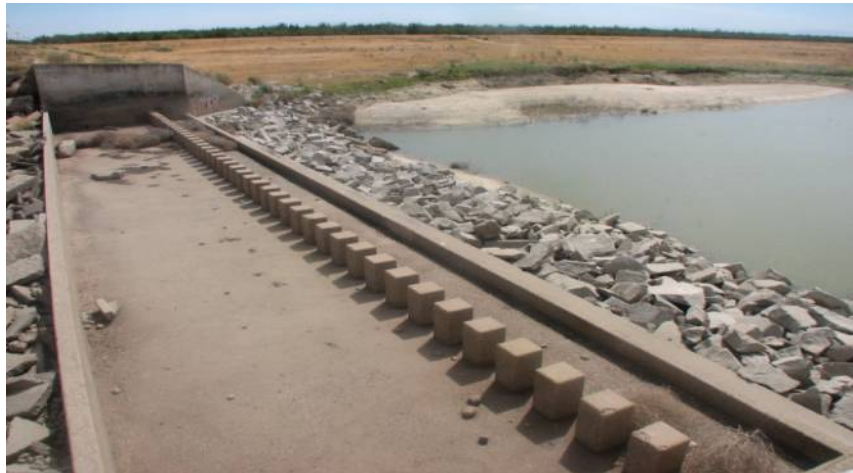
Report Line	5
Location	
Category	Structures & Concrete Lined Channels
Item	Concrete Foundations

Looking at the downstream side of the structure.

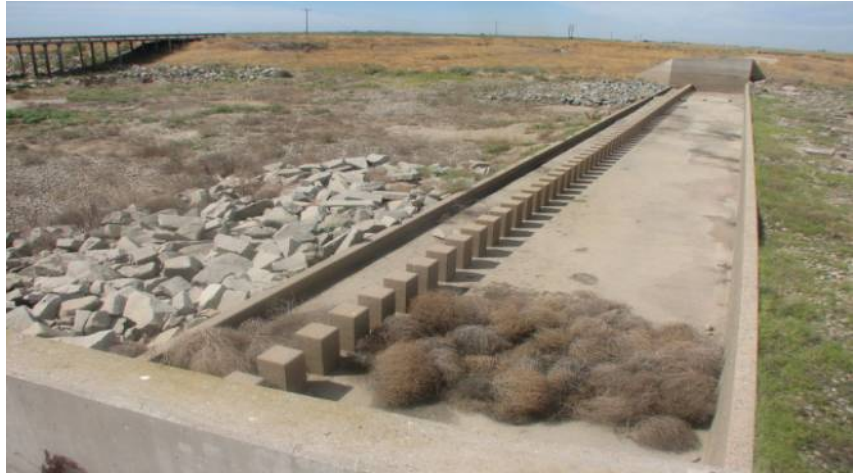
Report Line	5
Location	
Category	Structures & Concrete Lined Channels
Item	Concrete Foundations

Looking at downstream side of the structure

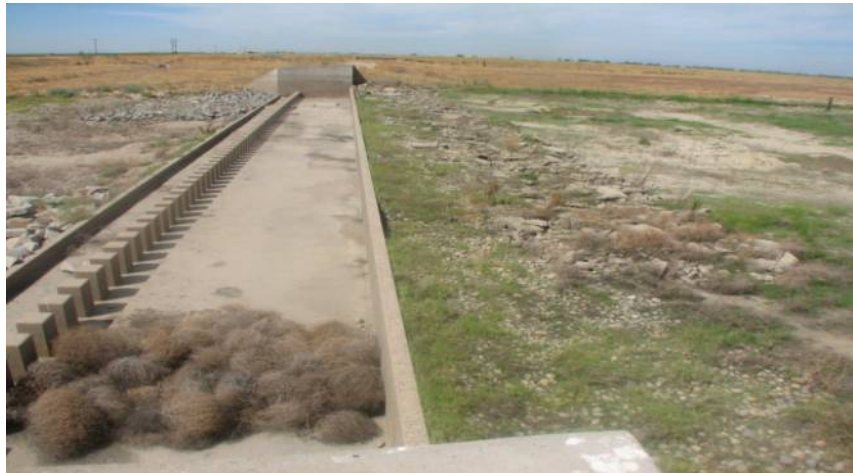
Report Line	5
Location	
Category	Structures & Concrete Lined Channels
Item	Concrete Foundations

Looking at the upstream side of the structure

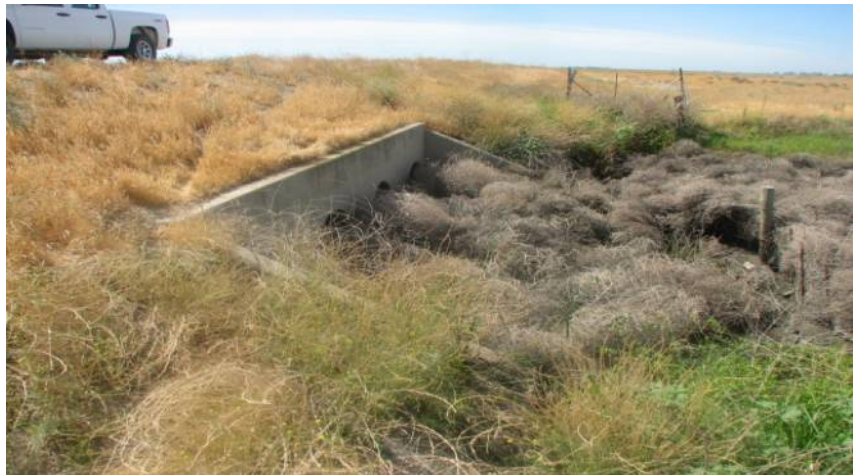
Report Line	1
Location	
Category	Structures & Concrete Lined Channels
Item	Vegetation & Obstructions

Looking at pipe inlet blocked with tumble weeds.

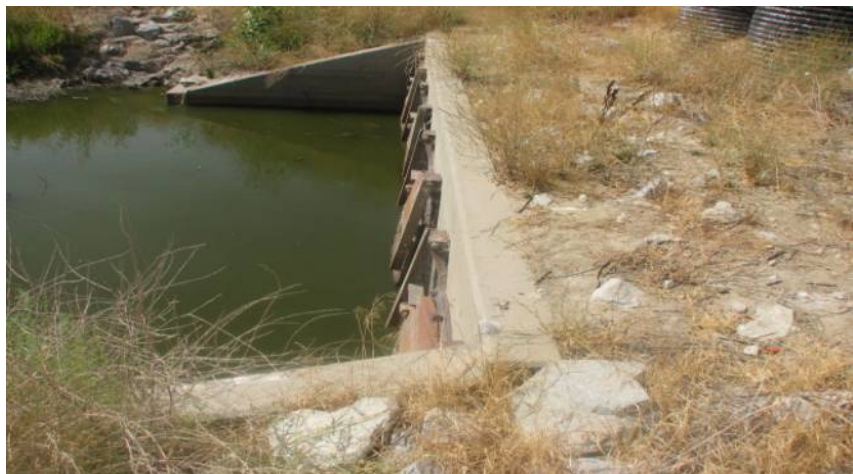
Report Line	5
Location	
Category	Structures & Concrete Lined Channels
Item	Flap Gates

Looking at flap gates in good operating conditions.

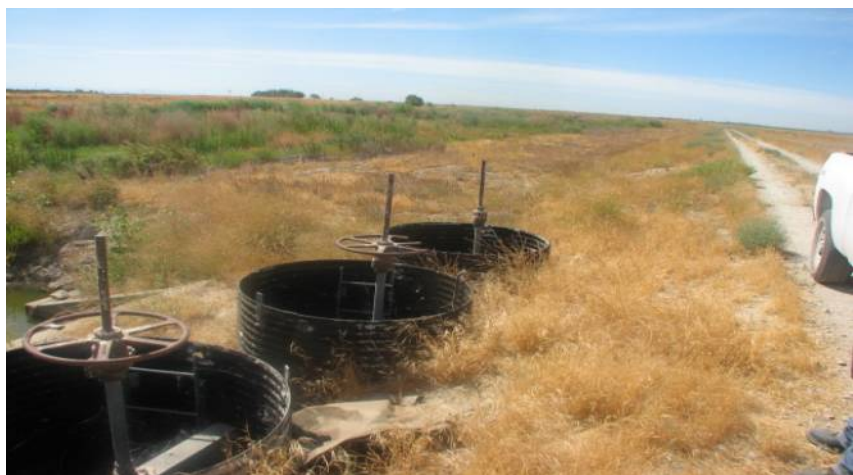
Report Line	6
Location	
Category	Structures & Concrete Lined Channels
Item	Manual Operations

Looking at broken and missing screw gate wheels.

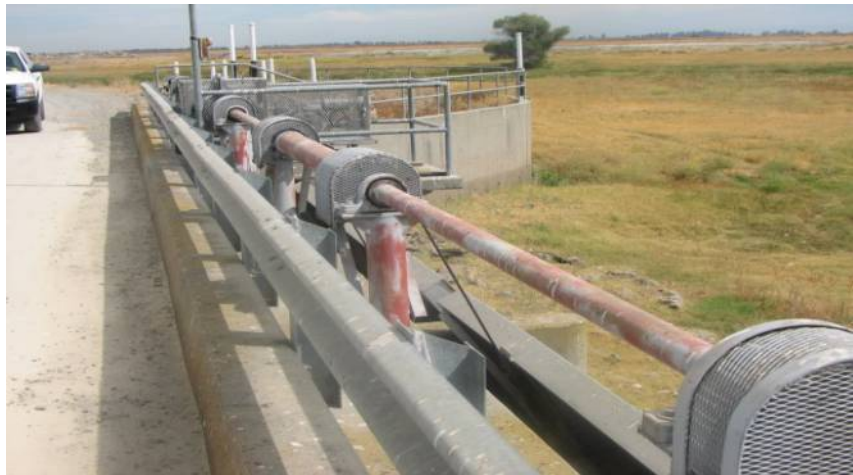
Report Line	1
Location	
Category	Pump Stations
Item	Motors, Engines, Fans & Gear Reducers
Looking at electrical equipment on upstream side of the structure.

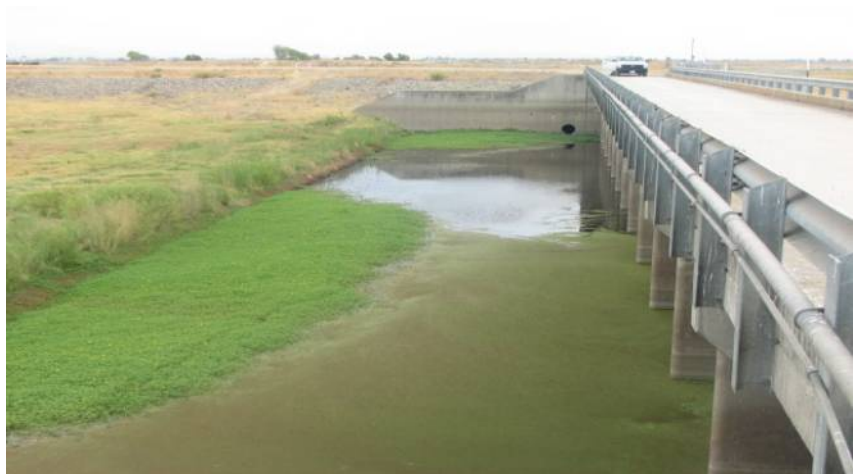
Report Line	3
Location	
Category	Structures & Concrete Lined Channels
Item	Revetments
Looking at vegetation growth on the revetment on the upstream side of the structure

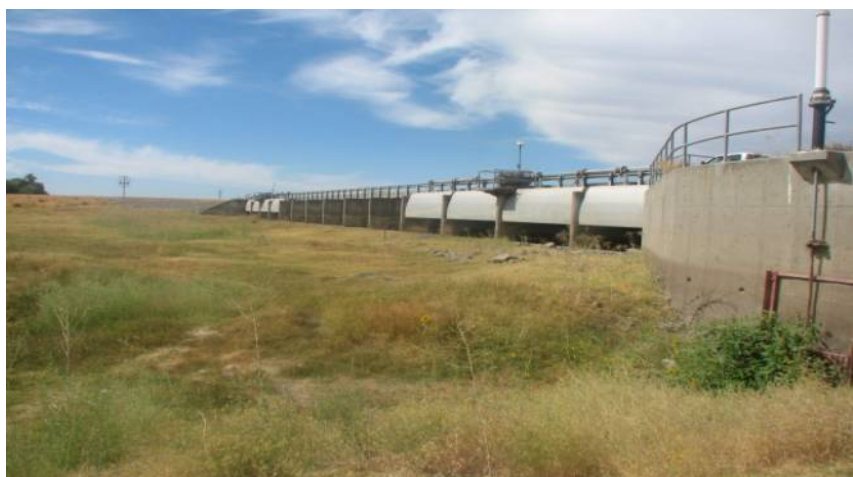
Report Line	6
Location	
Category	Structures & Concrete Lined Channels
Item	Concrete Foundations
Looking at upstream side of the structure.

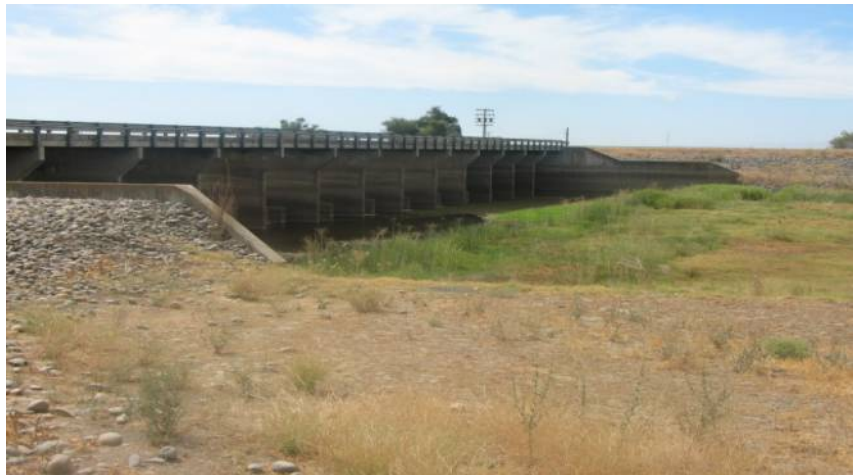
Report Line	6
Location	
Category	Structures & Concrete Lined Channels
Item	Concrete Foundations

Looking at the downstream side of the structure

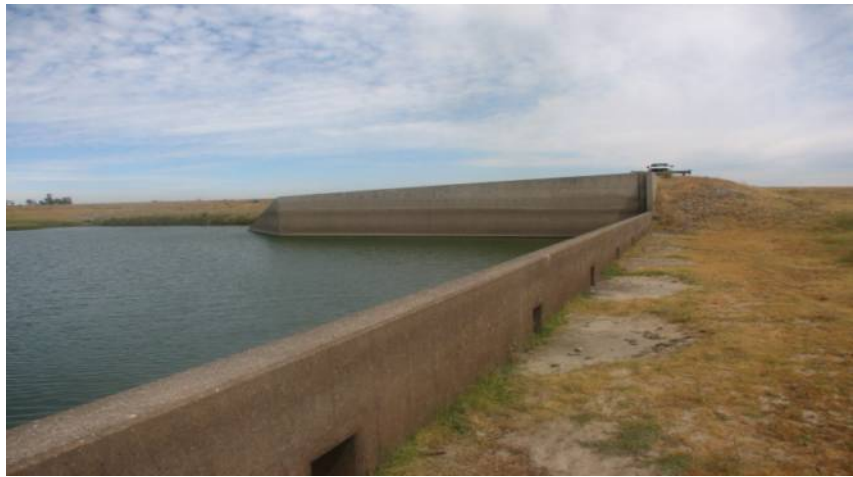
Report Line	4
Location	
Category	Structures & Concrete Lined Channels
Item	Concrete Foundations

Looking at upstream side of the structure

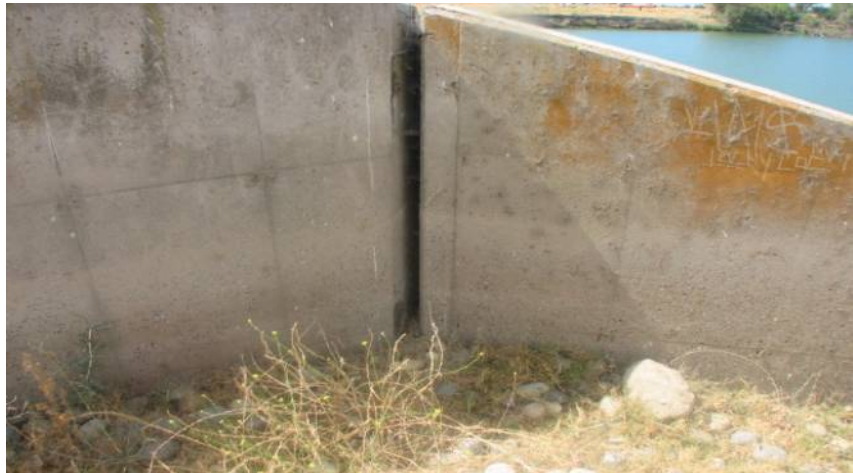
Report Line	5
Location	
Category	Structures & Concrete Lined Channels
Item	Monolith Joints

Looking at left bank wing wall monolith joint

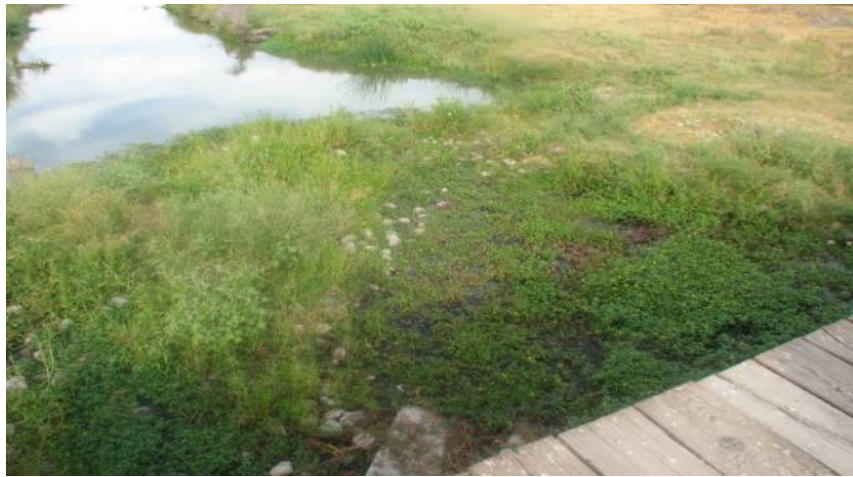
Report Line	1
Location	
Category	Structures & Concrete Lined Channels
Item	Vegetation & Obstructions

Looking at vegetation on upstream side of the structure

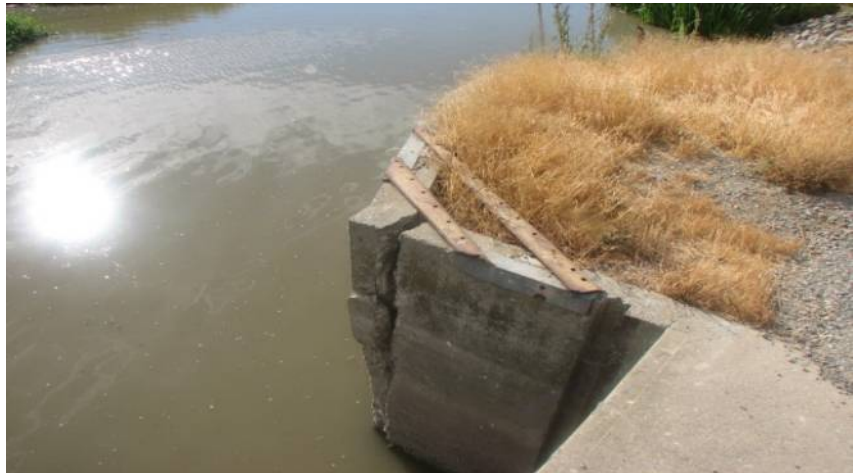
Report Line	3
Location	
Category	Structures & Concrete Lined Channels
Item	Concrete Surfaces

Looking at damage wing wall on the left bank of the downstream side of the structure

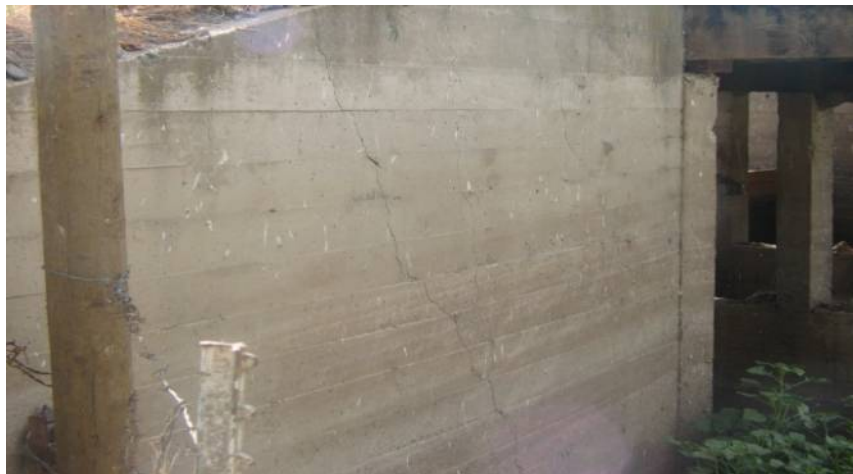
Report Line	3
Location	
Category	Structures & Concrete Lined Channels
Item	Concrete Surfaces

Looking at cracks on the right bank on the upstream side of the structure

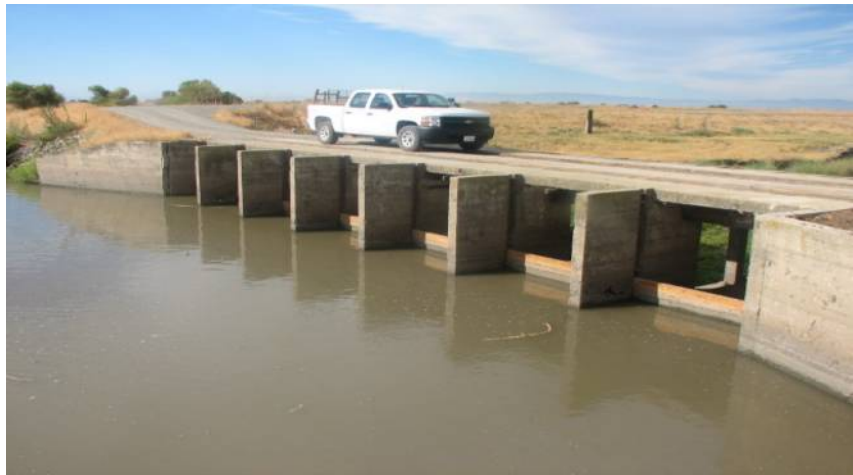
Report Line	4
Location	
Category	Structures & Concrete Lined Channels
Item	Concrete Foundations

Looking at the upstream side of the structure from the left bank.

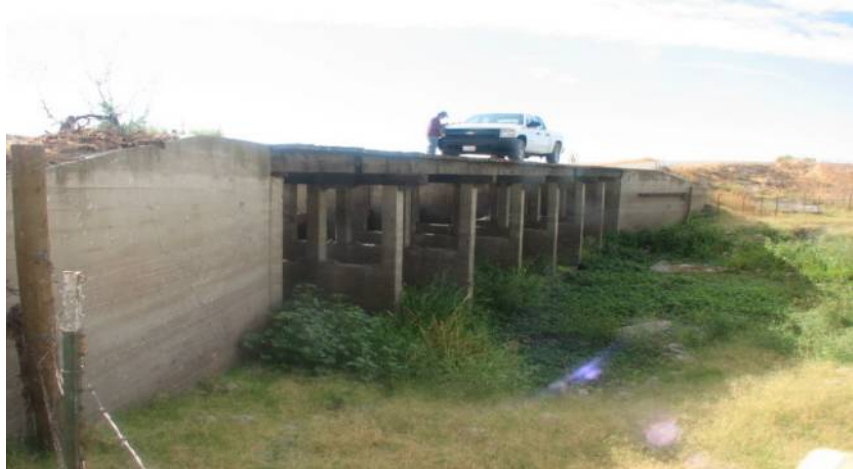
Report Line	4
Location	
Category	Structures & Concrete Lined Channels
Item	Concrete Foundations

Looking at downstream side of the structure.

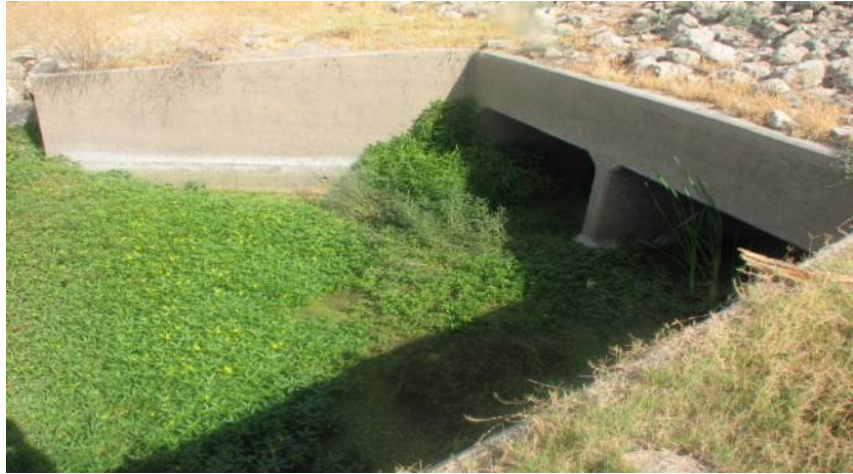
Report Line	2
Location	
Category	Structures & Concrete Lined Channels
Item	Revetments

Looking at vegetation on the discharge side of the structure.

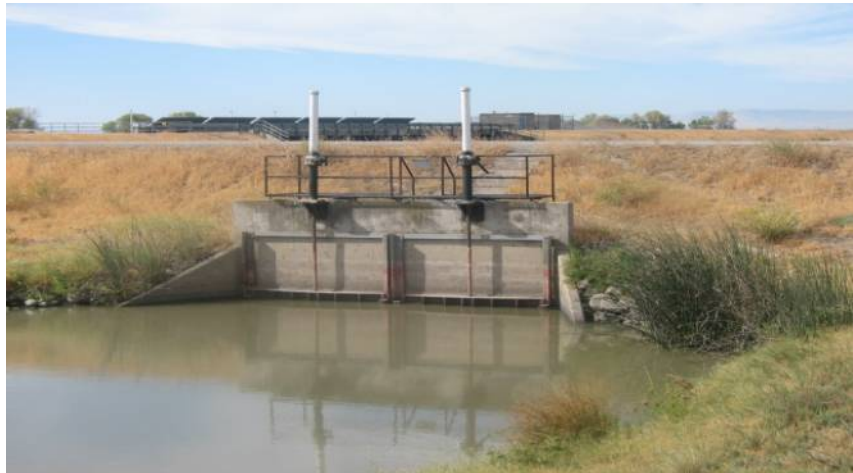
Report Line	3
Location	
Category	Structures & Concrete Lined Channels
Item	Culverts: Inlets / Outlets

View of the two 72 inch slide gates on the inlet side of the structure in good working condition.

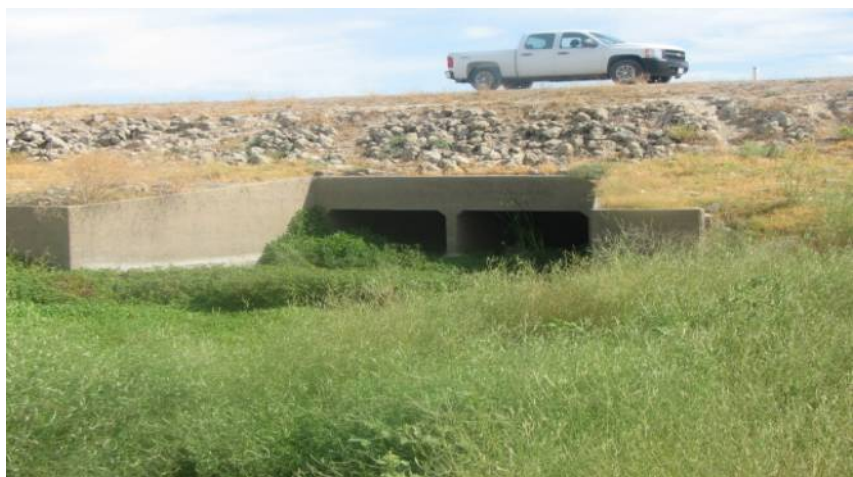
Report Line	5
Location	
Category	Structures & Concrete Lined Channels
Item	Concrete Foundations

Looking at the discharge side of the structure into the Eastside Bypass.

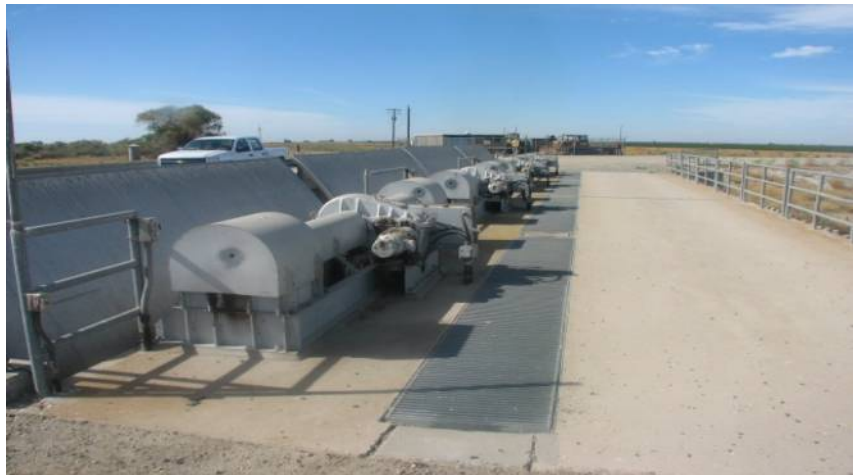
Report Line	4
Location	
Category	Structures & Concrete Lined Channels
Item	Vegetation & Obstructions

Looking at motors and gates on the downstream of the structure.

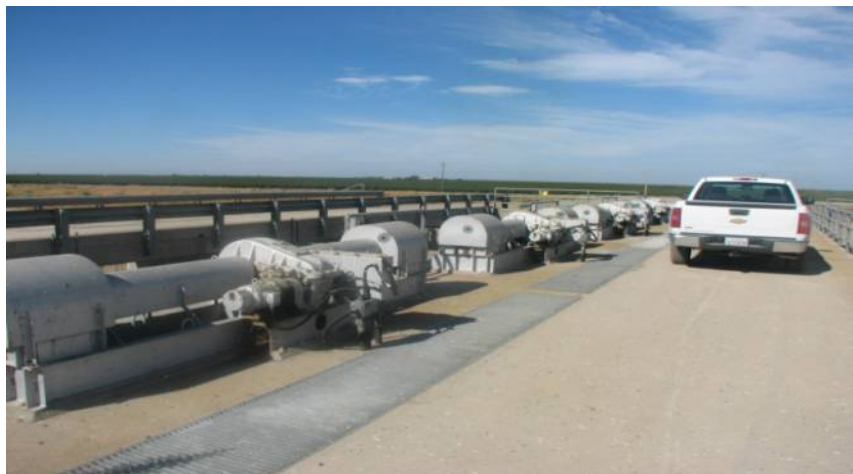
Report Line	10
Location	
Category	Structures & Concrete Lined Channels
Item	Electric Gate Operators

Looking at electric gates and motors.

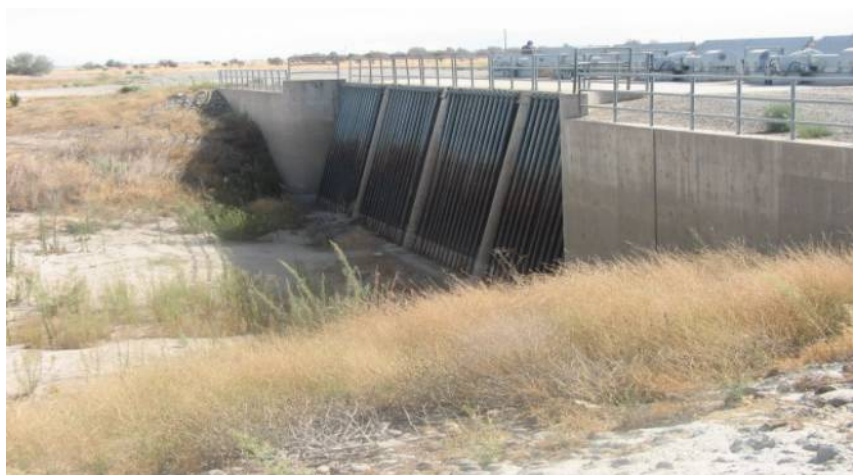
Report Line	14
Location	
Category	Structures & Concrete Lined Channels
Item	Concrete Foundations

Looking at the upstream side of the San Joaquin River structure

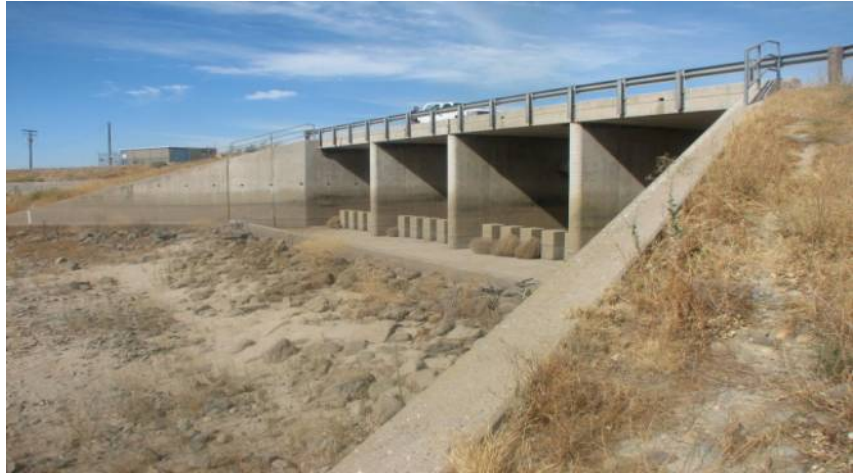
Report Line	14
Location	
Category	Structures & Concrete Lined Channels
Item	Concrete Foundations

Looking at the downstream side of the structure.

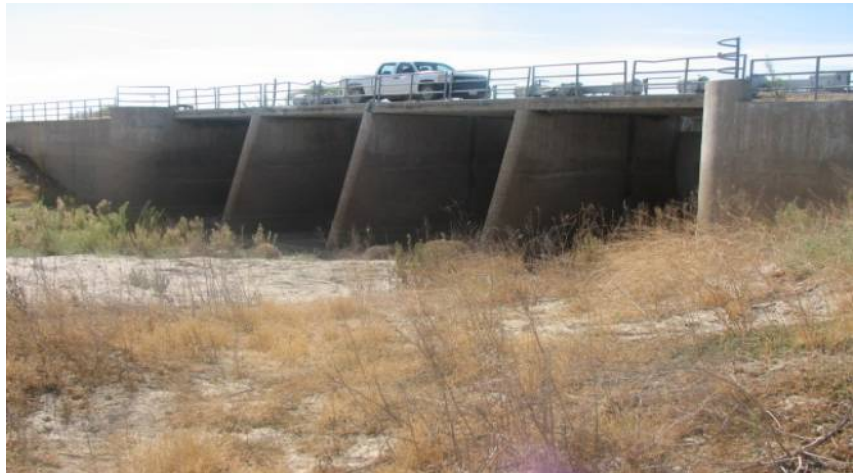
Report Line	15
Location	
Category	Structures & Concrete Lined Channels
Item	Concrete Foundations

Looking at the upstream side of the structure

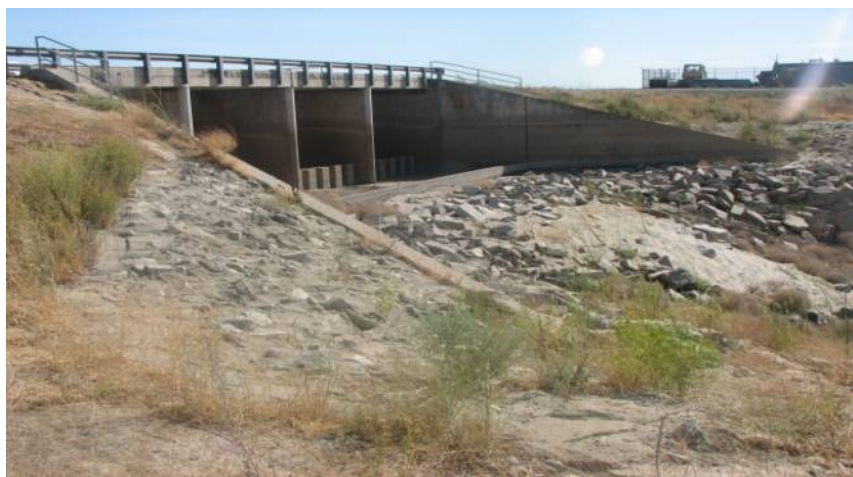
Report Line	15
Location	
Category	Structures & Concrete Lined Channels
Item	Concrete Foundations

Looking at the discharge side of the structure

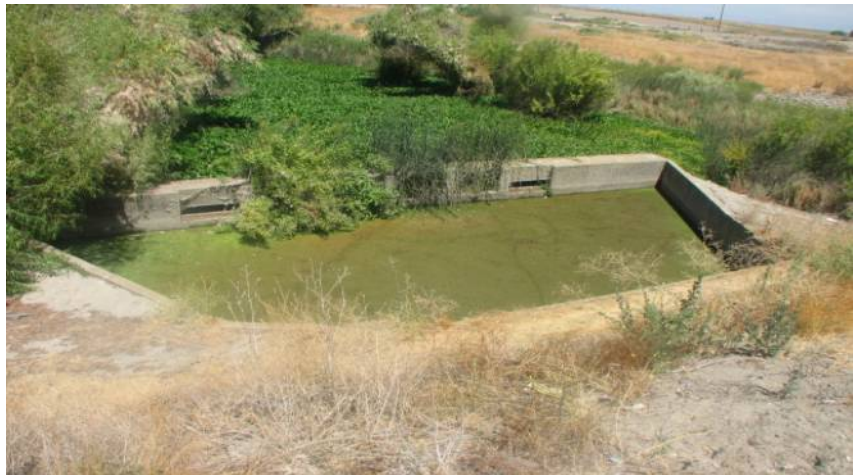
Report Line	1
Location	
Category	Structures & Concrete Lined Channels
Item	Vegetation & Obstructions

Looking at vegetation in channel on the inlet side of the structure.

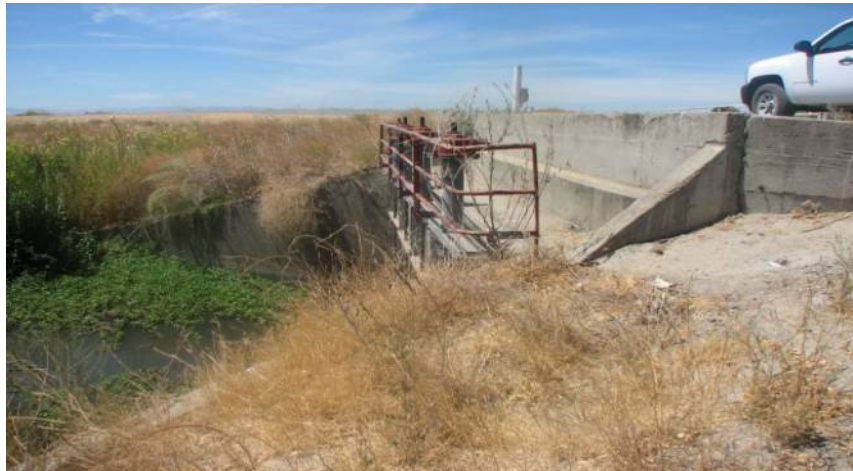
Report Line	6
Location	
Category	Structures & Concrete Lined Channels
Item	Manual Operations

Looking at the manual gates on the outlet side of the structure.

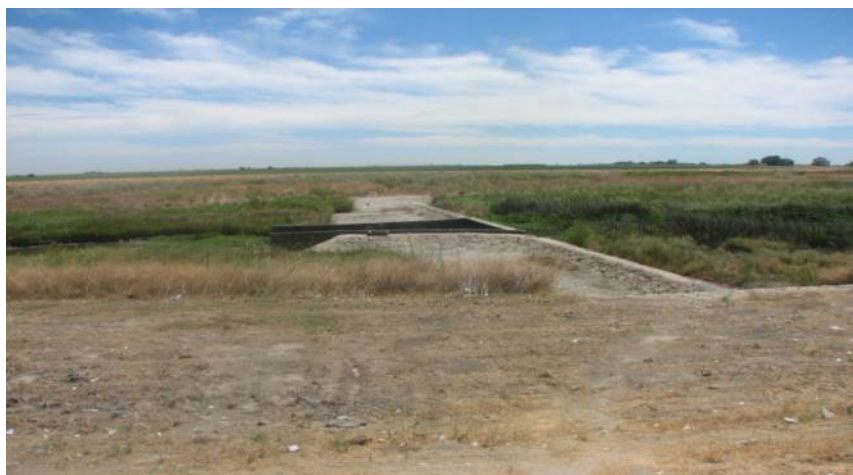
Report Line	9
Location	
Category	Structures & Concrete Lined Channels
Item	Concrete Foundations

Looking at overview of the structure from right bank

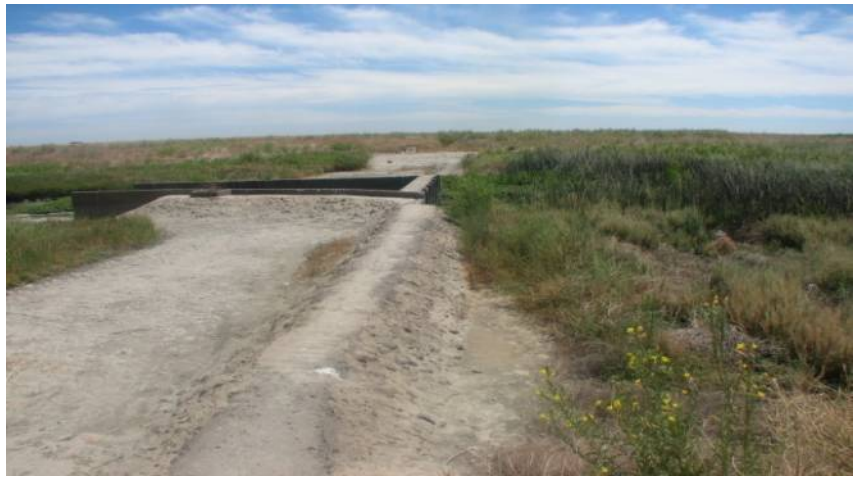
Report Line	9
Location	
Category	Structures & Concrete Lined Channels
Item	Concrete Foundations

Looking at the downstream side of the structure

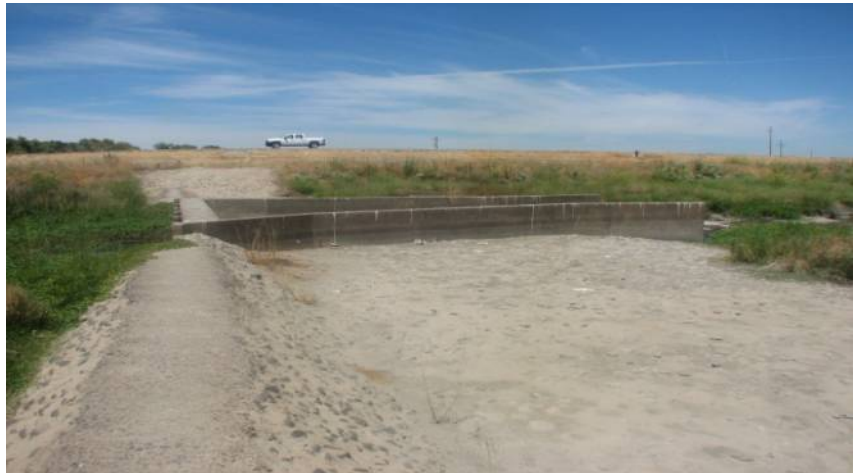
Report Line	9
Location	
Category	Structures & Concrete Lined Channels
Item	Concrete Foundations

Looking at the structure from the left bank
